# The Genesis Mosaic Restoration Project

**Julie Richey and team repair and rejuvenate a 50-year-old mural in time for its anniversary celebration**

**The Genesis Mosaic on the façade of the St. Jude Chapel on Main Street in downtown Dallas was in need of repair to maintain its stability and**

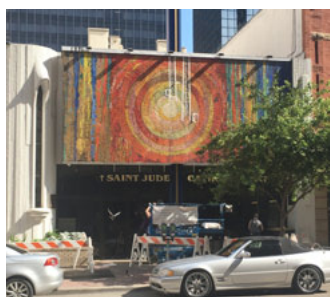
*restore its beauty. MIT professor Gyorgy Kepes' 1968 mosaic was suffering from two major fractures, smaller cracks, and mildew under the surface. Julie Richey and Cher Goodson put together a team to complete the arduous task. Six weeks after beginning, the Chapel was ready to celebrate its 50th anniversary in 2018.*

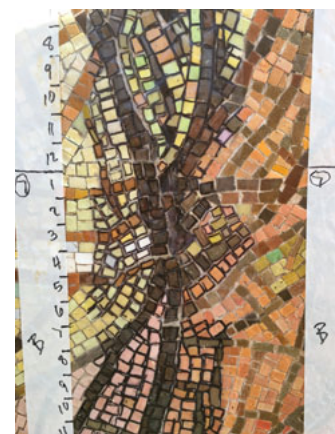
## MAPPING THE TESSERAE

Clear mosaic tape was used to capture the andamento, or pattern, of the tile before chiseling to remove tiles surrounding the fracture. Tiles were removed in 6-inch sections. Photo: Julie Richey

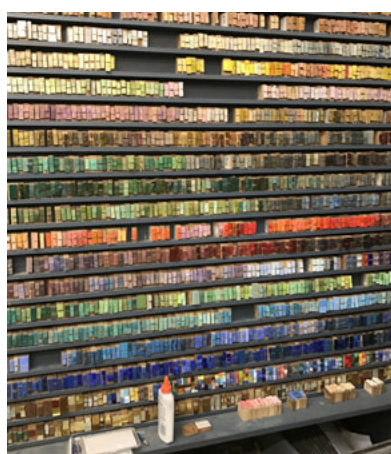
## THE HISTORIC PALETTE

We were so fortunate to have a long-time connection with Miotto Mosaics of Carmel, NY. Stephen Miotto is the godson of the founder of Venetian Art Mosaics Studios of the Bronx, NY, and when it closed, he took over the stock of Italian glass tiles. This allowed us to pull colors from the same stock used to make the original mosaic. Venetian Art Mosaics Studios was responsible for several wonderful architectural mosaics created for Dallas institutions in the 1960s. Photo: Mark Lefkin

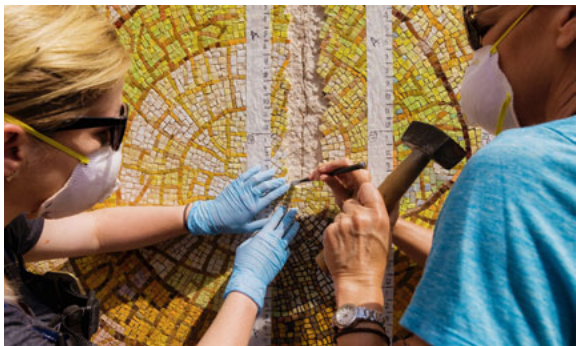
## REMOVING THE CRUMBLING SUBSTRATE

Callie and Julie use small stone chisels to remove the cracked and crumbling mortar. *Photo: Danny Fulgencio*

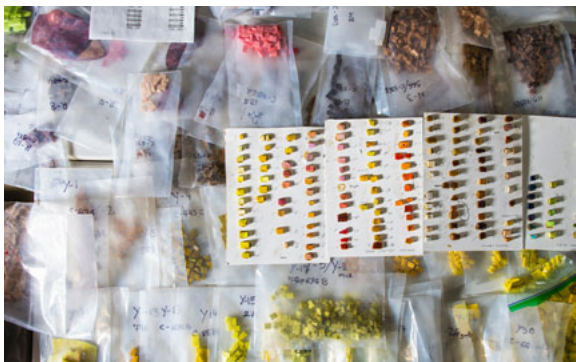
## COLOR PALETTE

We removed loose and damaged tiles surrounding the two vertical fractures. 140 distinct colors were counted in these two, thin cross sections. This didn't begin to quantify the colors on the outer reaches of the mosaic: malachite and lime greens, azures, violets, pinks, tangerines, and 24-karat gold leaf tiles. *Photo: Danny Fulgencio*

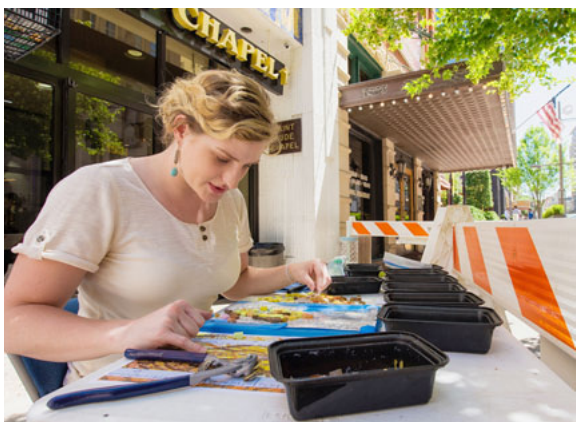
## CALLIE ASSEMBLING PAGES OF MOSAIC

She became our impromptu public relations rep when curious passers-by stopped to ask about our project. *Photo: Danny Fulgencio*

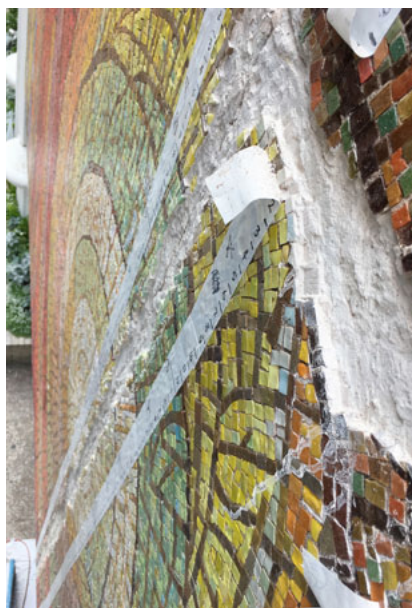
## SURPRISE!

It was understood when we embarked on this preservation project that there were possibly more areas damaged than appeared on the surface. We were disappointed to find a horizontal fracture invisible from the street, which traversed the two vertical fractures. This fracture was treated with the same care as the verticals. Fortunately it wasn't too deep. *Photo: Julie Richey*

Mildew growing behind the tiles forced many of them to delaminate. The fractures, most likely caused by the building's settling event, then leaked water due to improper flashing on the roof. Now that the roof has been repaired and the mosaic is not subjected to water damage from behind, the fracture is dry. The mildew was neutralized with a bleach gel. *Photo: Julie Richey*

An interesting detail of the mosaic was the curve on the southern side of the façade. This area was almost completely covered in 24-karat gold leaf Venetian glass—beautiful, but very thin tile. The mortar here was very fragile. Attempts to prepare the surface for just a few tiles to be resealed resulted in twice as many falling out. We waterproofed the area and made an invisible repair. *Photo: Julie Richey*

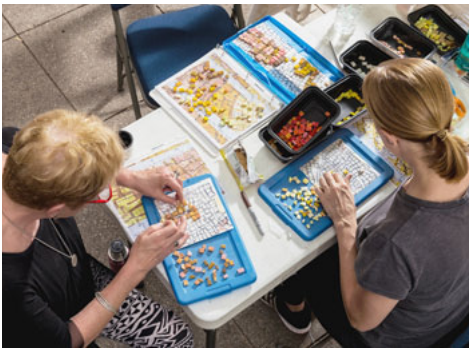
## RECREATING THE SECTIONS

Once we carefully documented the areas to be removed, cleaned the tiles, and received replacements from the stock at Miotto Mosaics Studios in NY, we were ready to rebuild.

Using both printed “before” photos of the mosaic and our iPads and iPhones (for easy enlargement of the details), we were able to identify original tiles and put them right back next to their neighbors. A classic example of ancient craft and modern technology working together.

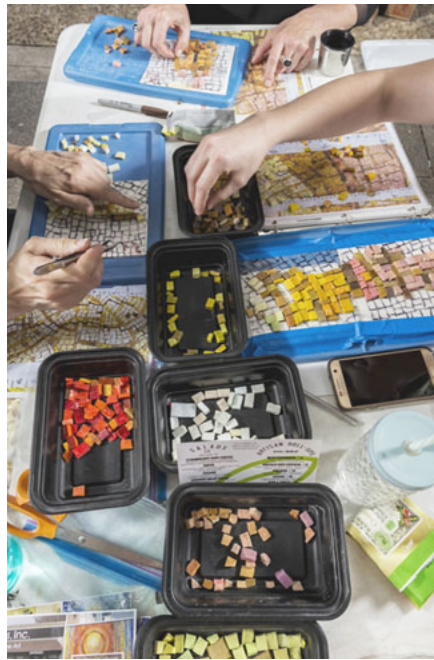
## PUZZLE TIME

Careful attention to color, shape, and pattern allowed our three “puzzlers” to rebuild the missing sections. The lids served as “trays” for each page of rebuilt section. *Photo: Danny Fulgencio*

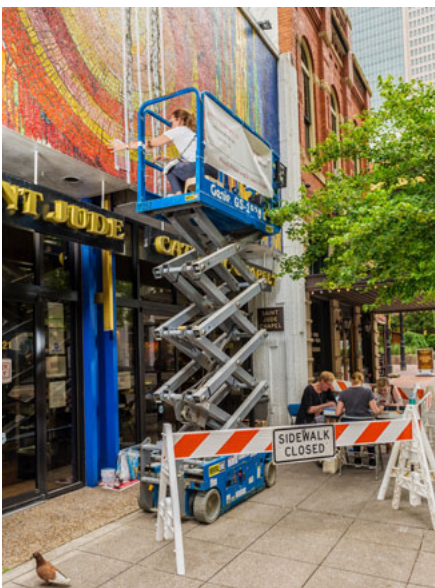
## BEGINNING THE REBUILD

Julie Richey begins at the bottom of the small fracture, replacing tiles from the pattern. *Photo: Danny Fulgencio*

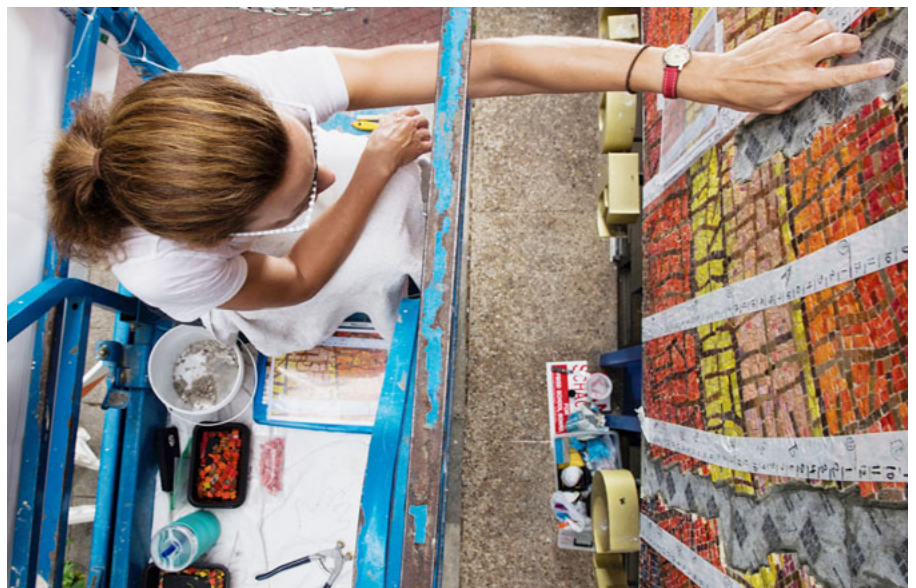
## PLACING THE ANTI-FRACTURE MEMBRANE

We were fortunate to have a great local rep from Laticrete International, the company that provided our mortars, grouts, and anti-fracture compounds. In this case, it was Hydro Ban® Anti-Fracture Tape to the rescue. We coated the seams with Hydro Ban, then applied thinset and the custom-cut membrane. This provided a stable base for the replacement mosaic, and we are confident that the membrane will keep the old fractures at bay. *Photo: Danny Fulgencio*

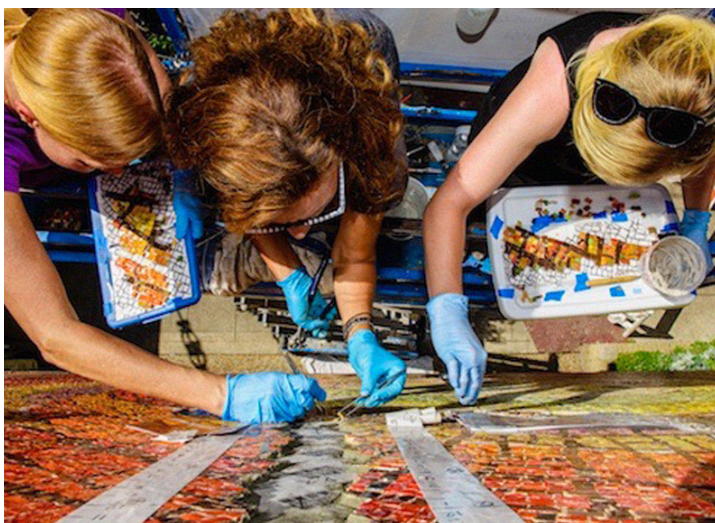
## RE-PIECING BEGINS

It takes three to accomplish this task: Callie on the right is working on the thinner fracture; the wider fracture requires a tracker (Lynne on the left) and a fixer (Julie in the middle) to keep the tesserae and patterns in line. Photo: Danny Fulgencio

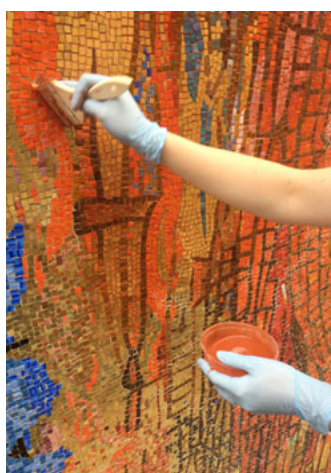
## THE RED WASH 2

Conservator Callie Heimburger created a special "wash" of Indian red and burnt umber to unify the design by coloring joints and mortar to match the intensity of the glass tesserae. This process was used in the installation of the original mosaic in 1968. We know this because we found traces of the pinkish-red stain under the loose tiles. Photo: Julie Richey

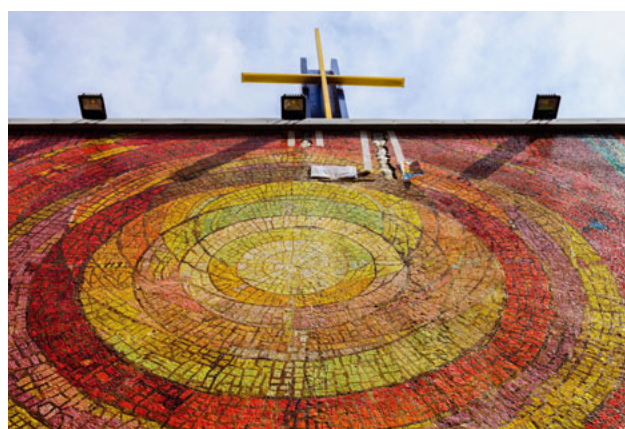
## ALMOST FINISHED

Once the replacement of tiles along the fractures was complete, it was time to spot-grout low areas, and clean and replace randomly missing tiles across the façade. Photo: Danny Fulgencio
